Water Quality in the Bad River Watershed

Prepared by: Naomi Tillison

Water Quality Monitoring: Total Phosphorus

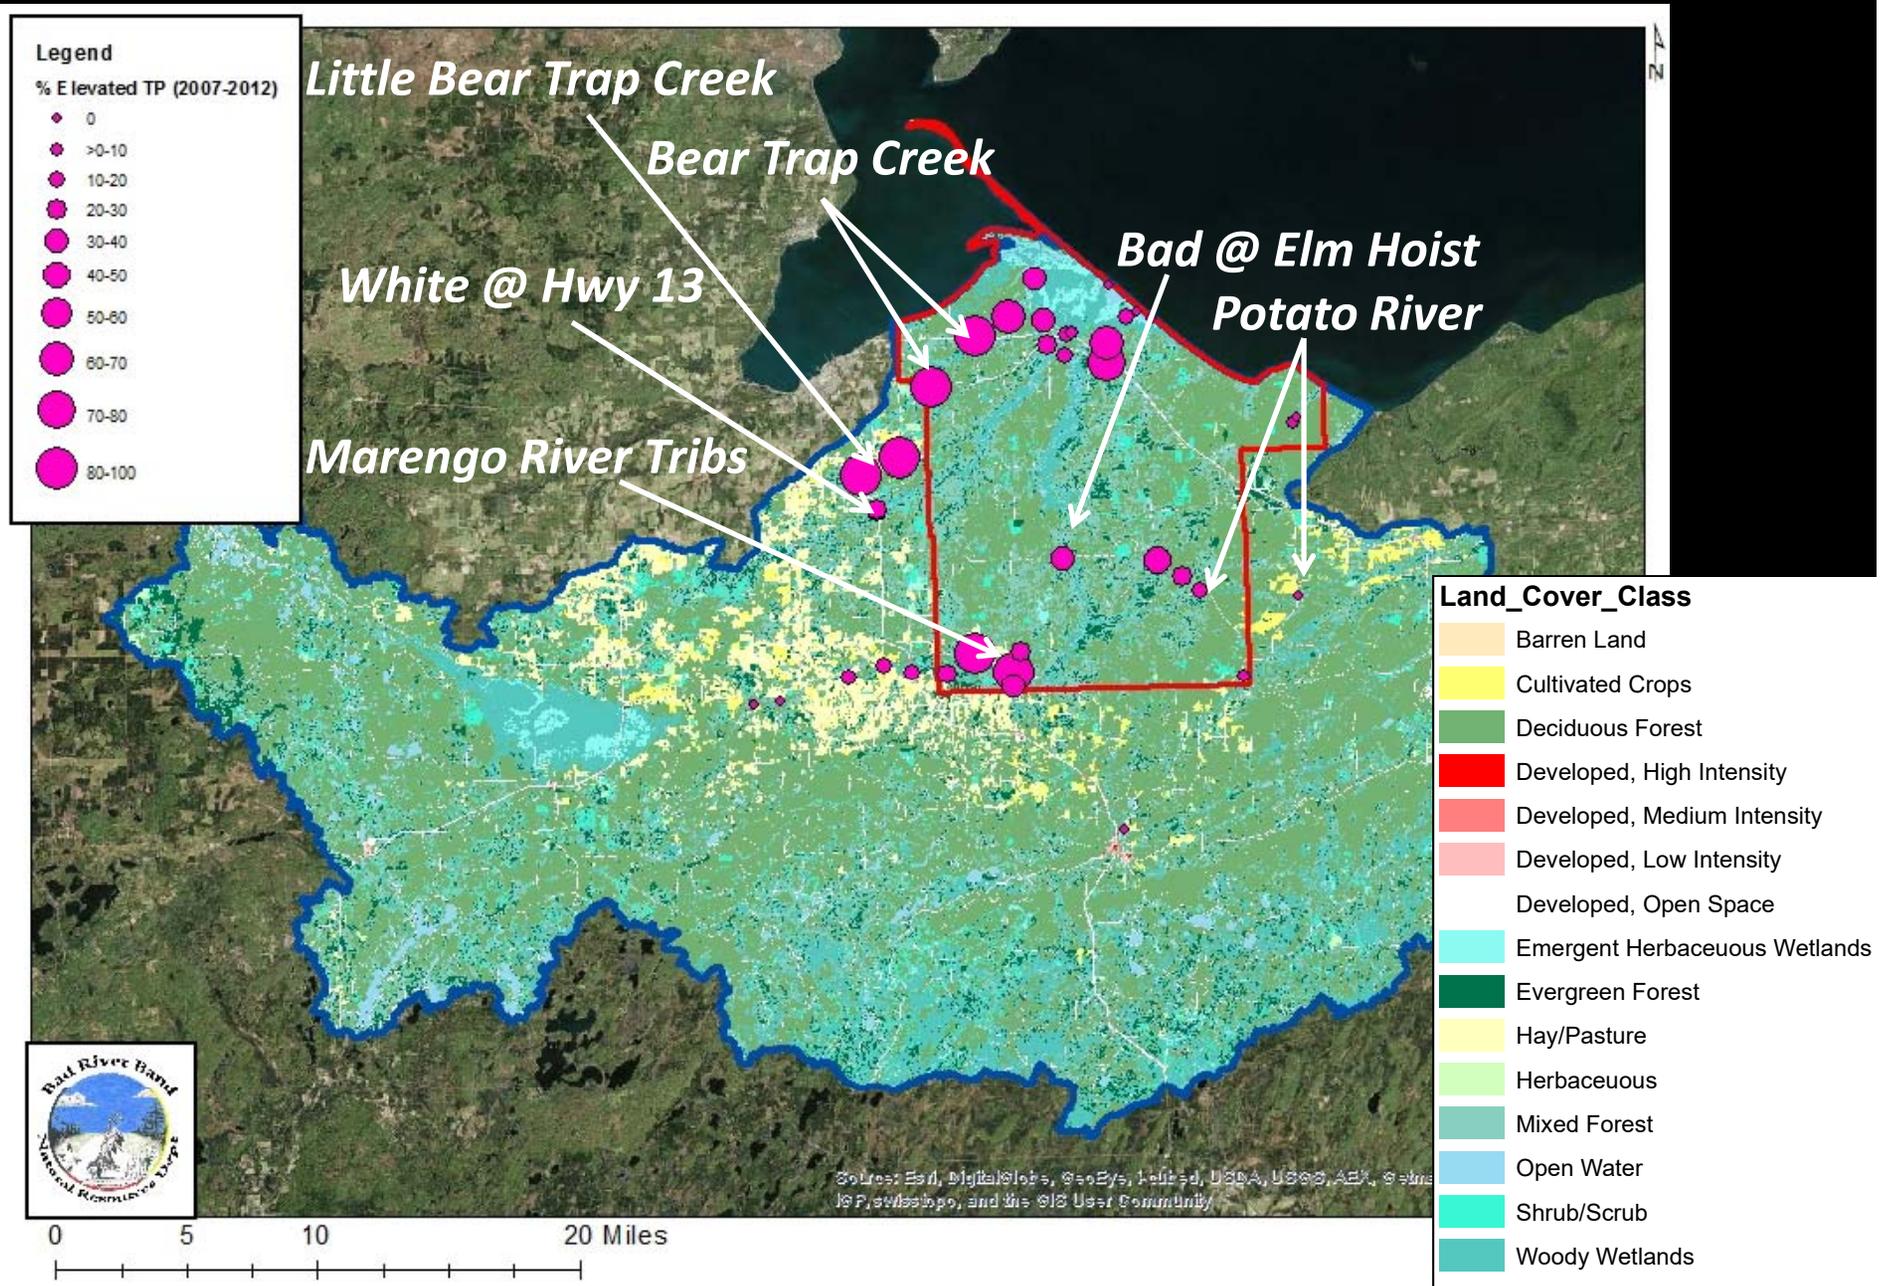
% of Samples with Elevated TP (2007-2012)

Bad River Natural Resources Department collects water samples from select surface water sites that are analyzed for total phosphorus (TP). The next two maps illustrate the percentages of samples collected at each site that had elevated TP concentrations. Please note that the number of samples collected varies by site and varies by year.

Samples with a concentration of 0.075 mg/L or greater are considered elevated TP concentrations; this concentration is one of Wisconsin's numeric water quality criteria applicable to streams. The TP criteria was derived to protect fish and aquatic life.

In 2007-2012, 449 out of the 822 samples collected and analyzed for TP had elevated concentrations. Out of the 38 sites sampled, 9 sites had over half of the samples with elevated TP. These 9 sites were located within the Marengo River watershed, the Beartrap Creek portion of the Lower Bad watershed, or the Denomie Creek portion of the Lower Bad watershed.

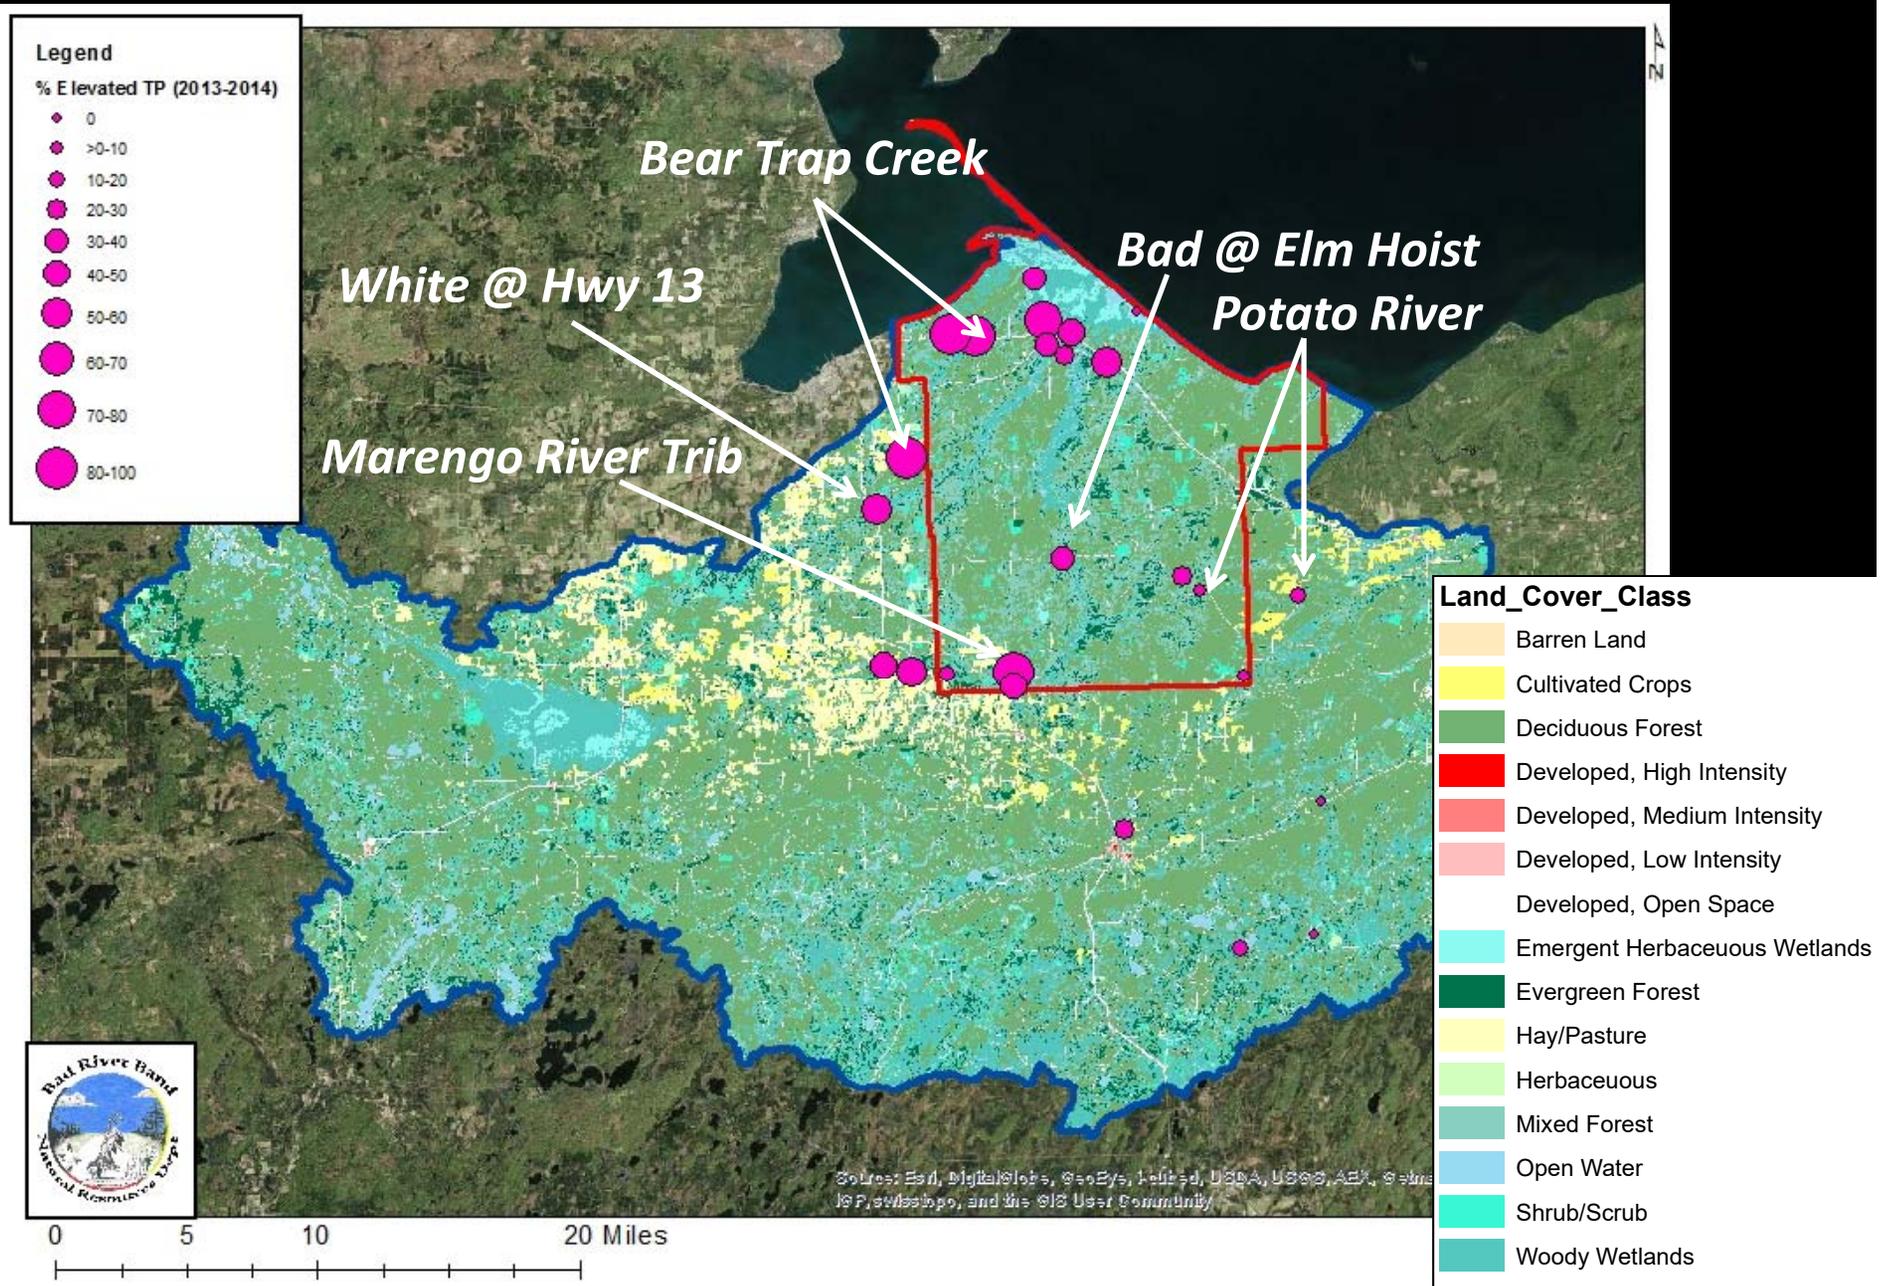
% of Samples with Elevated TP (2007-2012)

In 2013-2014, 106 out of the 226 samples collected and analyzed for TP had elevated concentrations. Out of the 26 sites sampled, 11 sites had over half of the samples with elevated TP. These 11 sites were primarily located within the Marengo River watershed, the White River watershed, the Beartrap Creek portion of the Lower Bad watershed, or the Denomie Creek portion of the Lower Bad watershed.

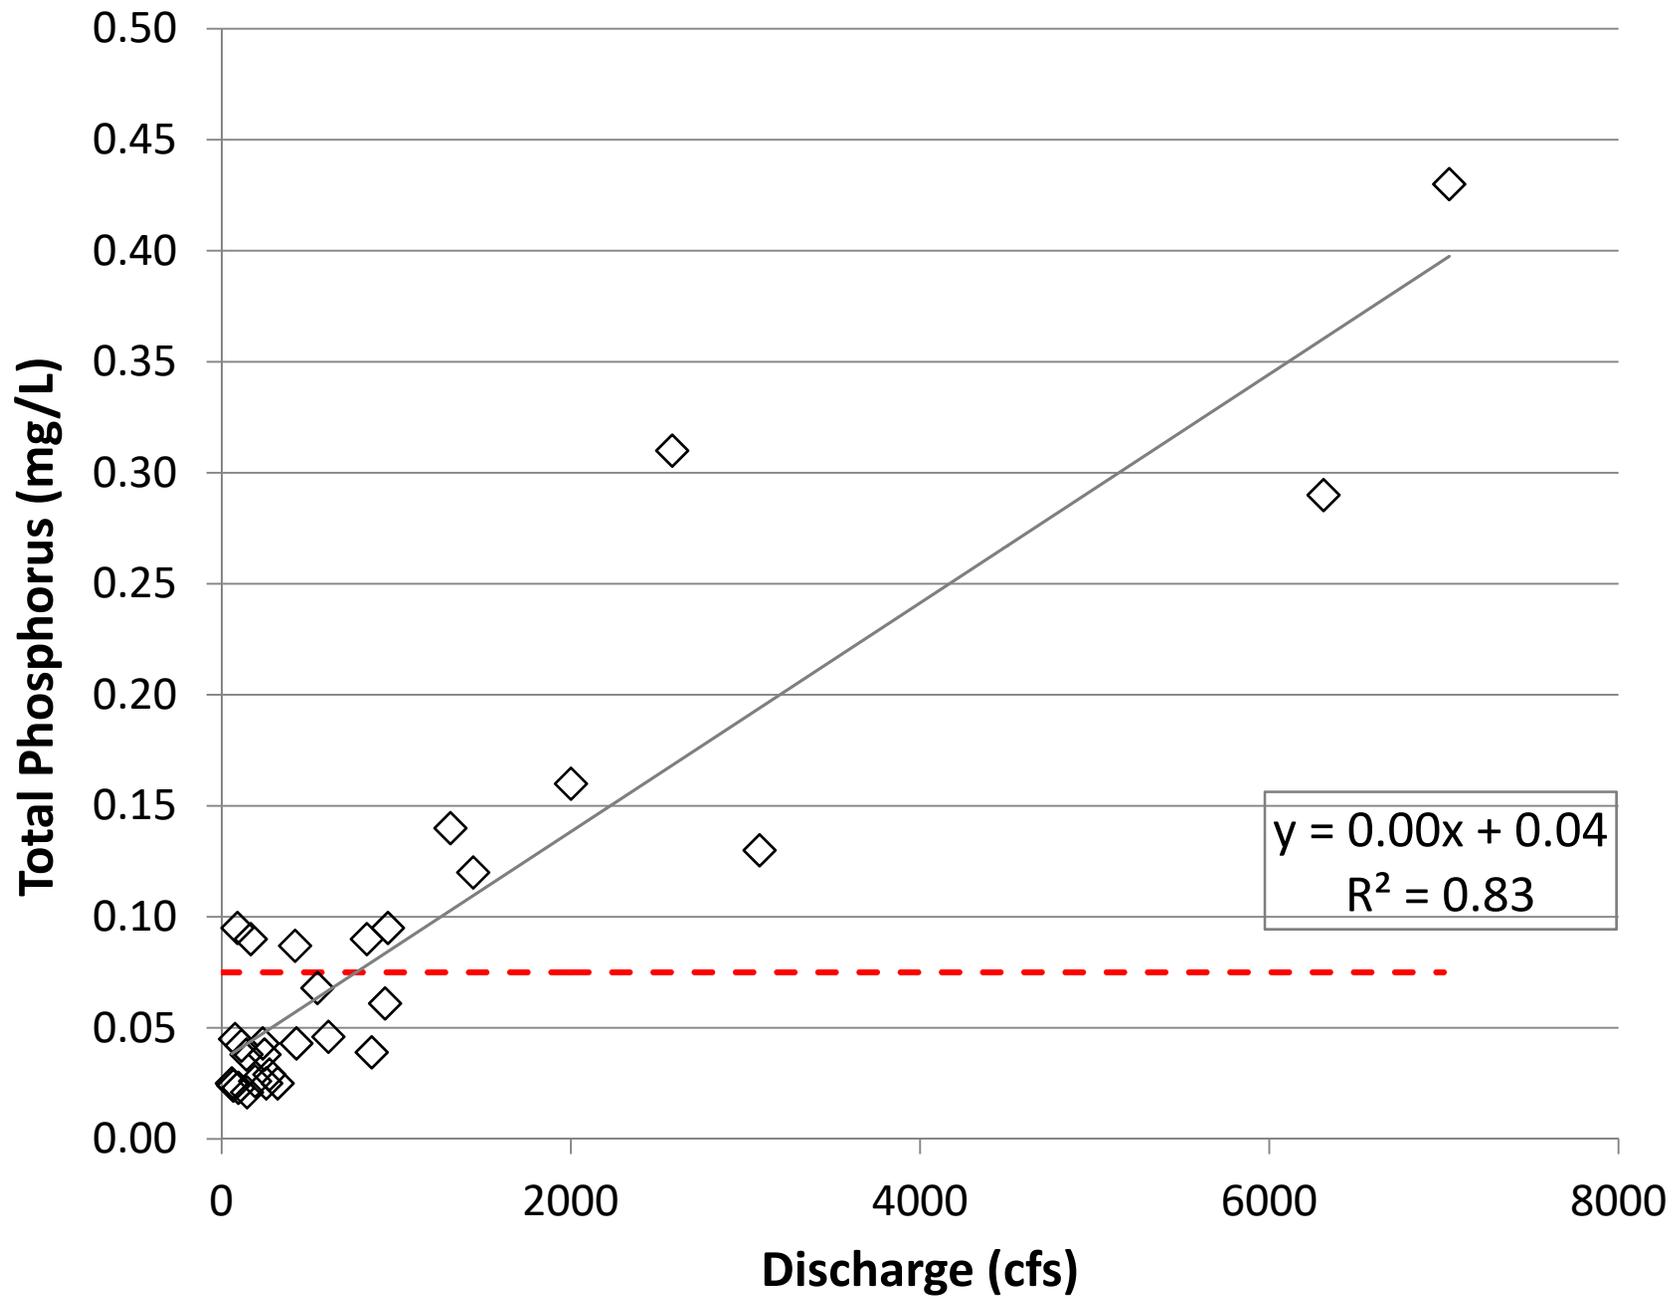
The graph following this slide illustrates the total phosphorus (TP) concentrations measured in the Bad River at the Elm Hoist Road crossing increase with flow (or discharge). The data displayed was collected between 2007-2012 and includes the discharge (in cubic feet per second or cfs) measured by U.S. Geological Survey.

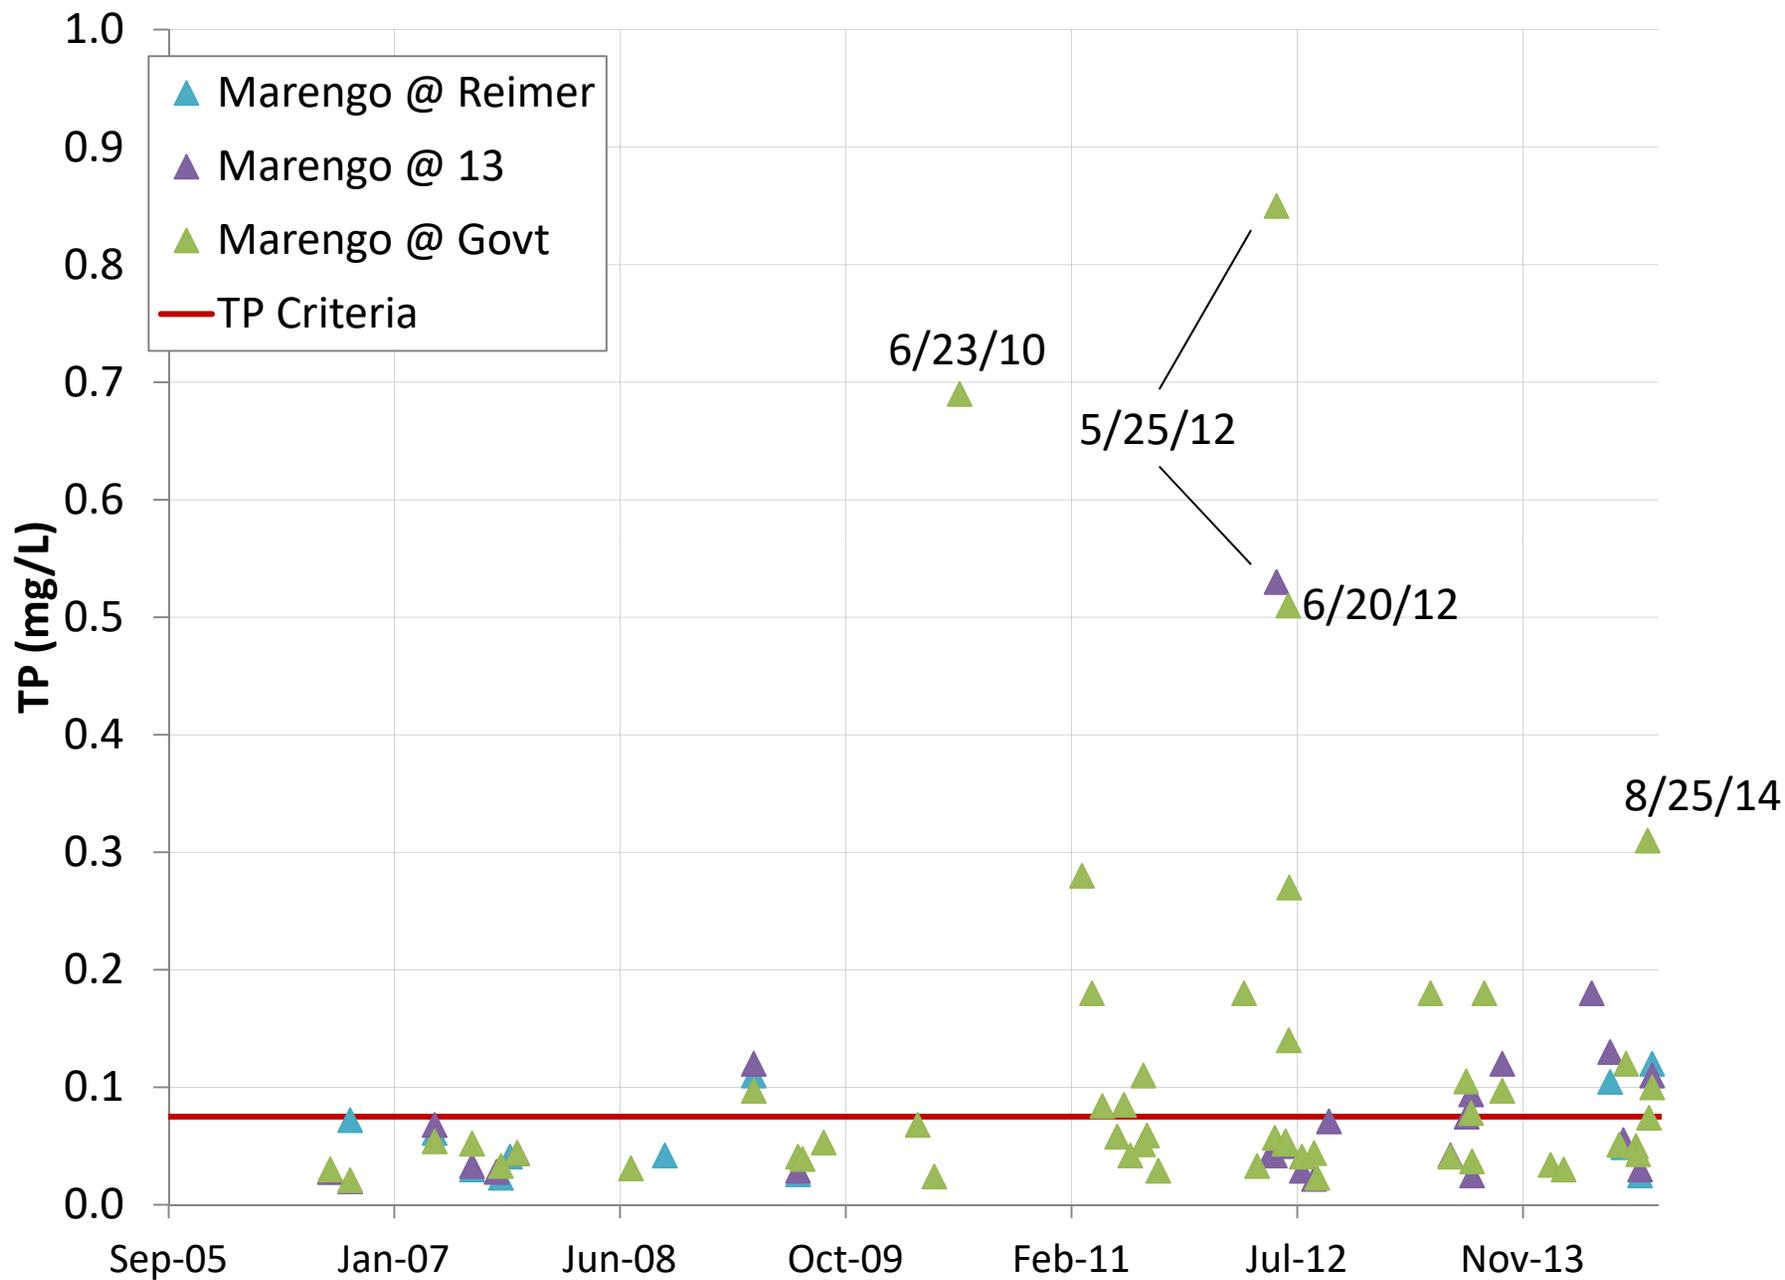
The second graph following this slide displays the TP concentrations collected at three sites located on the Marengo River from 2006-2014. The TP criteria of 0.075 mg/L is displayed as a red line on this graph to help visualize the samples with elevated TP concentrations.

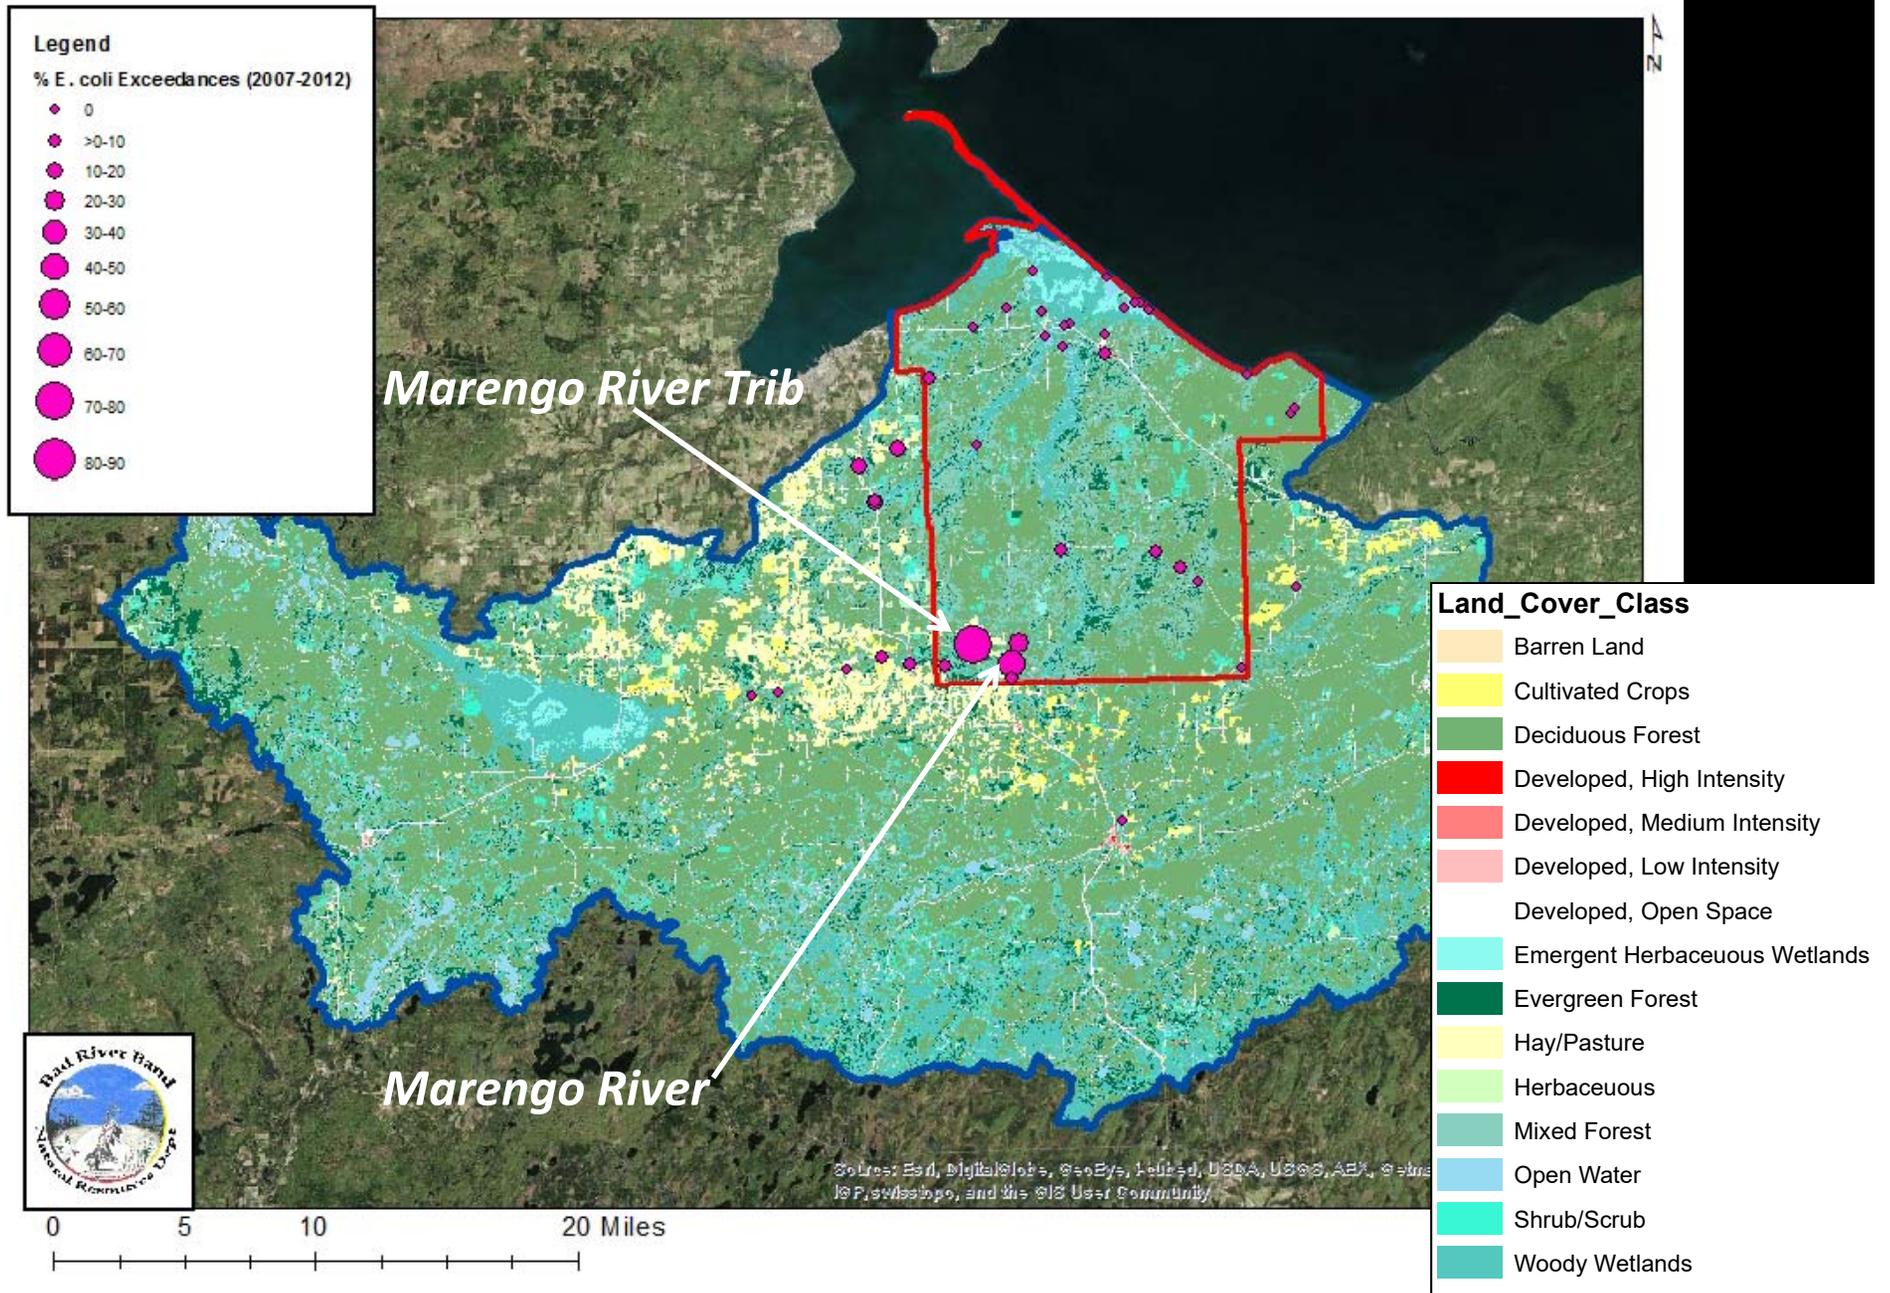
% of Samples with Elevated E. coli (2007-2012)

Bad River Natural Resources Department collects water samples from select surface water sites that are analyzed for E. coli. The next two maps illustrate the percentages of samples collected at each site that had elevated E. coli concentrations. Please note that the number of samples collected varies by site and varies by year.

Samples with a concentration of 235 CFU/100 mL or greater are considered elevated E. coli concentrations; this concentration is Bad River Tribe's numeric water quality criteria applicable to surface waters. The E. coli criteria was derived to protect human health during swimming or other primary contact activities.

In 2007-2012, 60 out of the 1137 samples collected and analyzed for E. coli had elevated concentrations. Out of the 41 sites sampled, 2 sites had over 40% of the samples with elevated E. coli. These 2 sites were located within the Marengo River watershed.

In 2013-2014, 35 out of the 253 samples collected and analyzed for E. coli had elevated concentrations. Out of the 46 sites sampled, 5 sites had over 40% of the samples with elevated E. coli. These 5 sites were located within the Marengo River watershed.

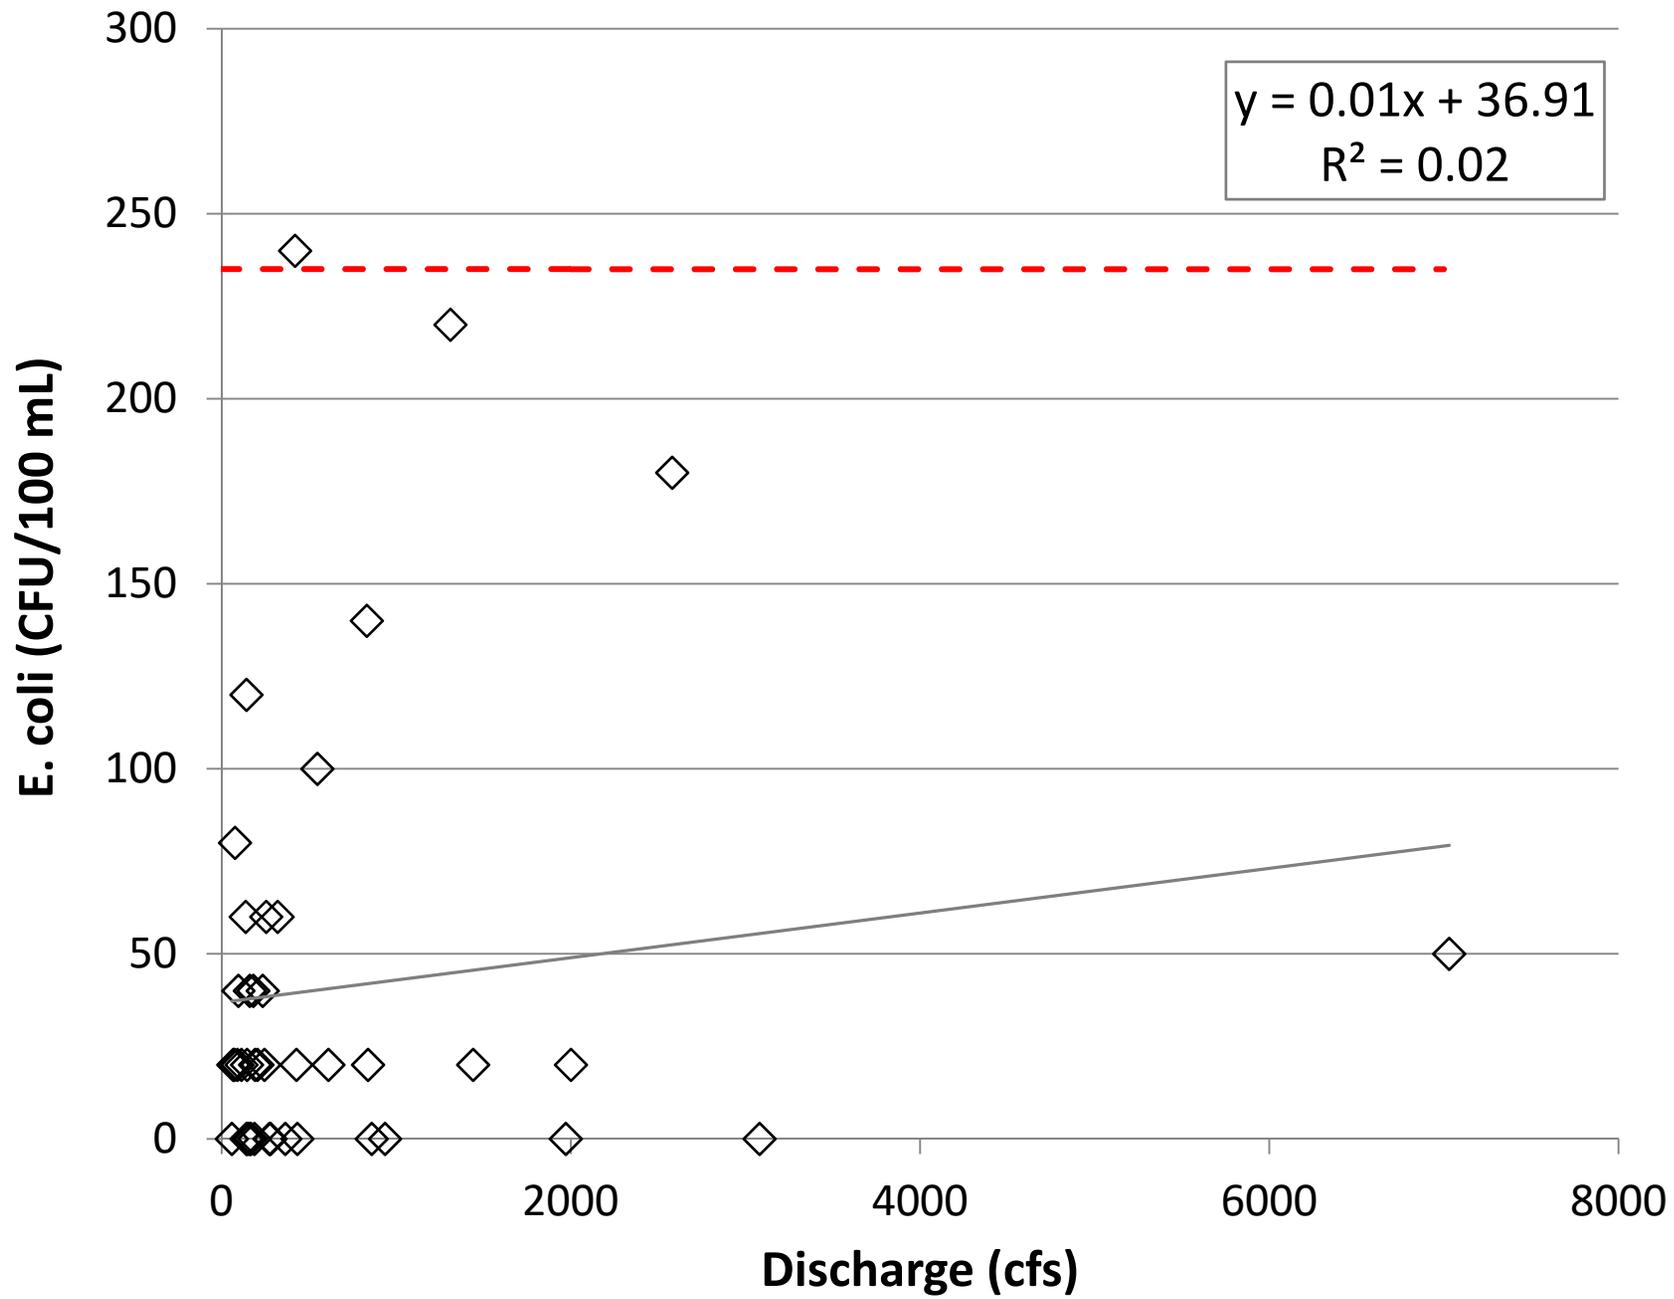
The graph following this slide illustrates the E. coli concentrations measured in the Bad River at the Elm Hoist Road crossing does not have a strong correlation with flow (or discharge). The data displayed was collected between 2007-2012 and includes the discharge (in cubic feet per second or cfs) measured by U.S. Geological Survey.

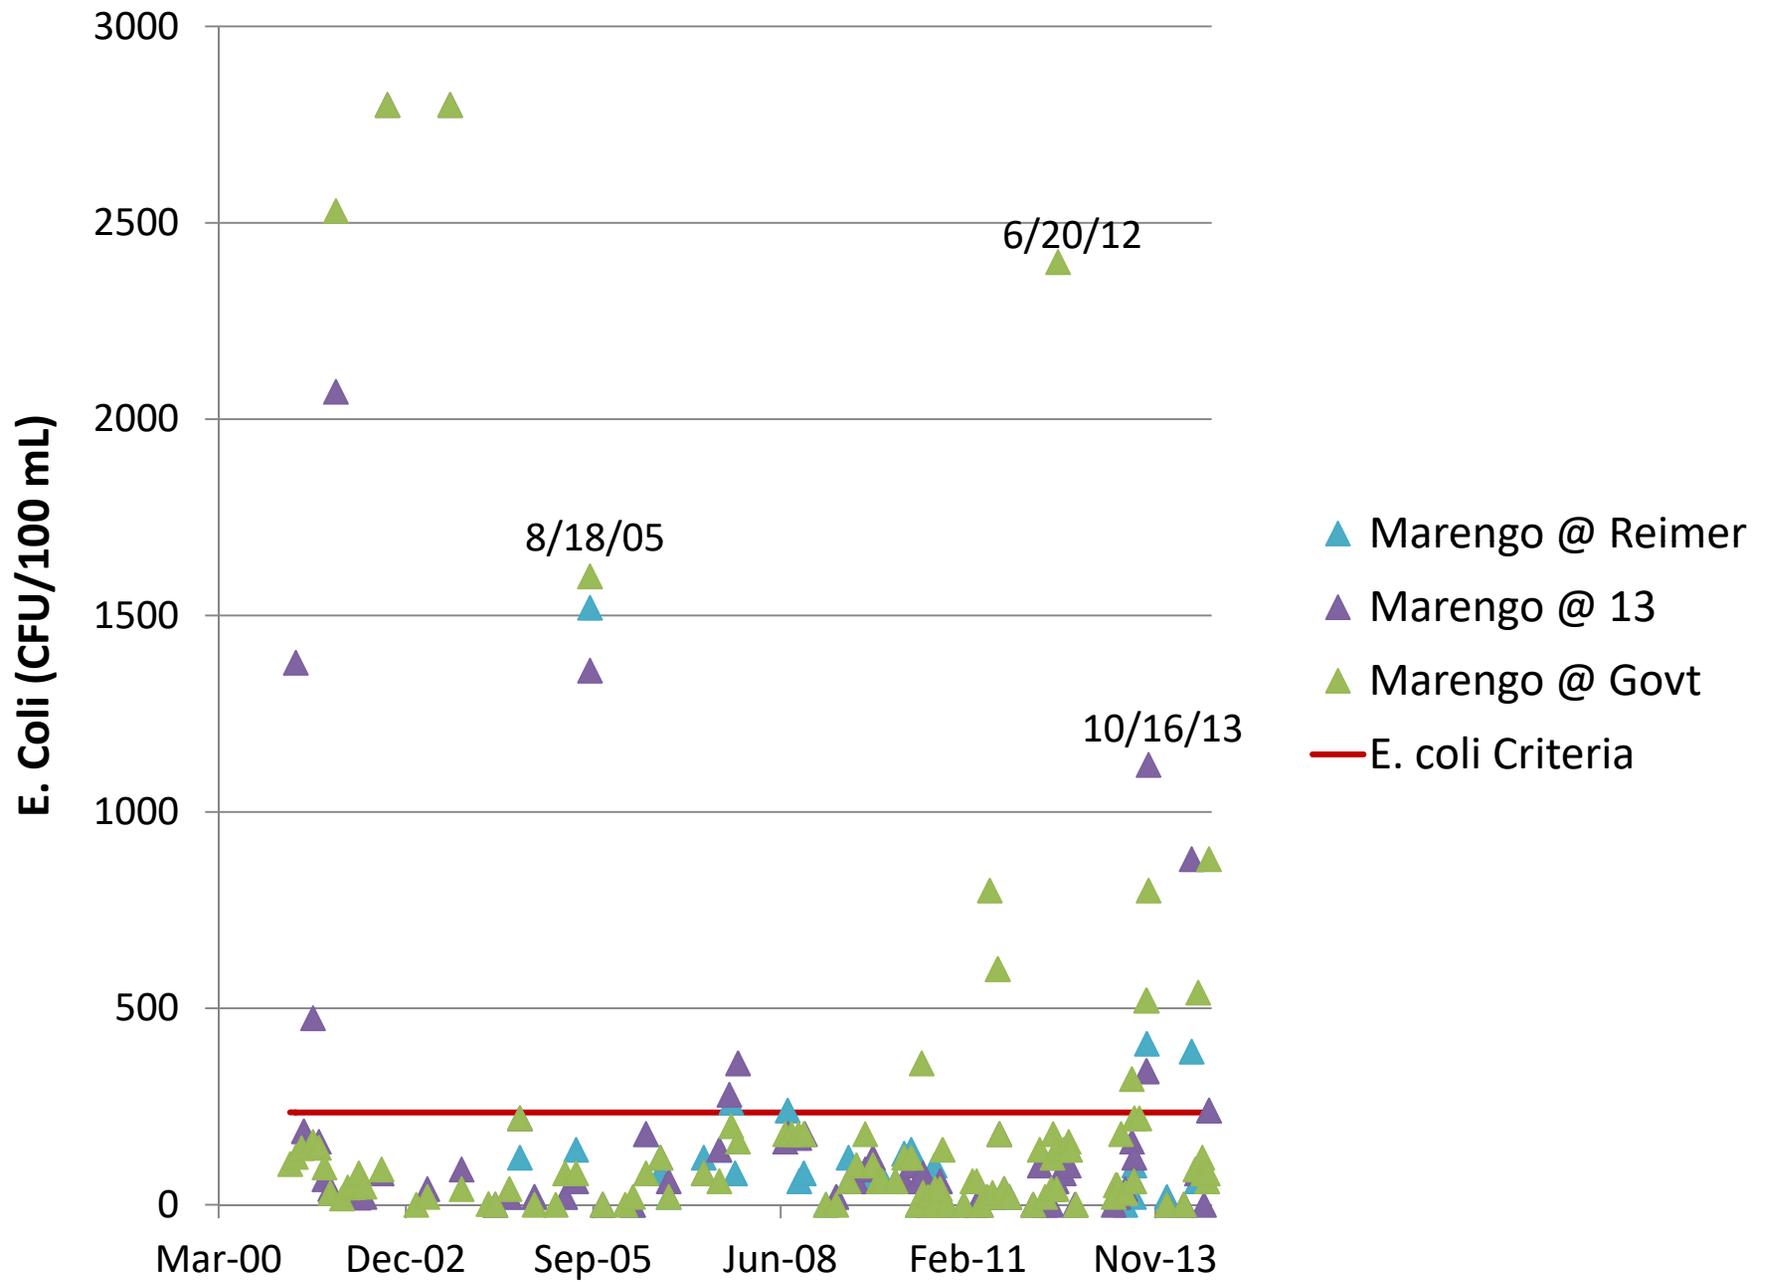
The second graph following this slide displays the E. coli concentrations collected at three sites located on the Marengo River from 2001-2014. The E. coli criteria of 235 CFU/100 mL is displayed as a red line on this graph to help visualize the samples with elevated E. coli concentrations.
